St. Ursula's Church Berne

Report energy efficiency initiative 2014/15

Hans Goepfert, for the Energy Project Team

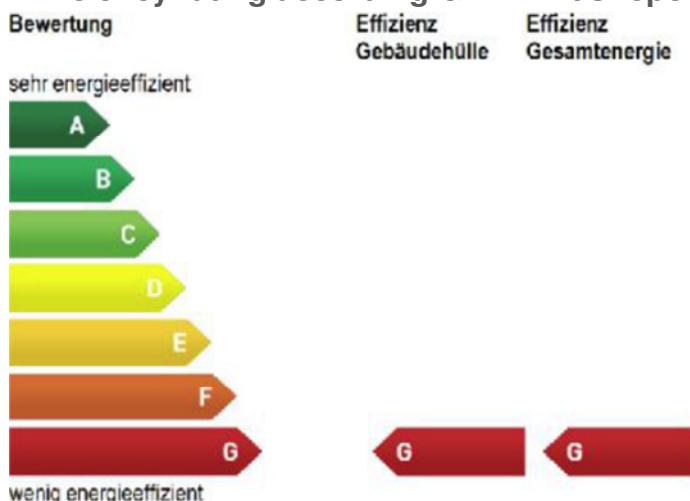
Efficiency rating according GEAK Plus report:

The measure for energy efficiency is the quotient of the energy loss divided by the room volume. In our case the result indicates a low efficiency. The office for environmental coordination and energy of the canton of Berne classes the chaplain's house according the below chart in the lowest of 7 categories (pls refer. To the GEAK report in annex IX)
